Joe Moyneur Construction

Property Inspection Report

address: XX XXXXXXXX DR
 Rancho Santa Margarita, CA 92688

Inspection date: Tuesday, November 11, 2008

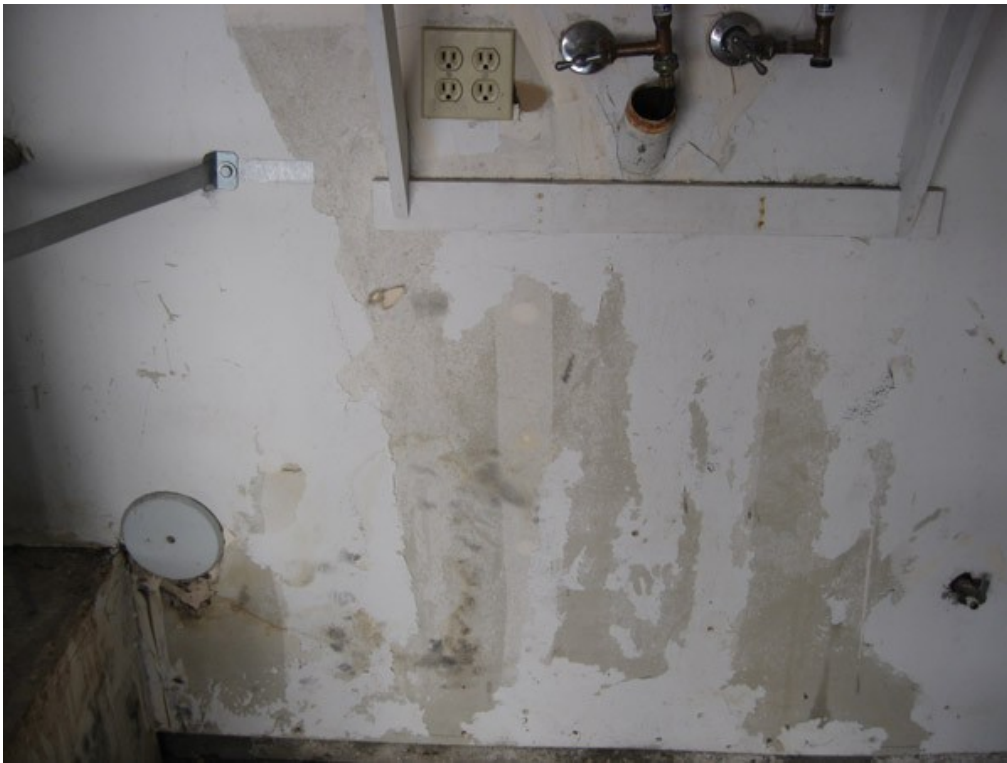
Photo 2

Evidence of water damage & mold was found on drywall at washer & dryer area and at hot water heater. The Center for Disease Control (CDC) defines this as more than 20 feces per square foot. Rodent infestation may be a safety hazard due to the risk of contracting.

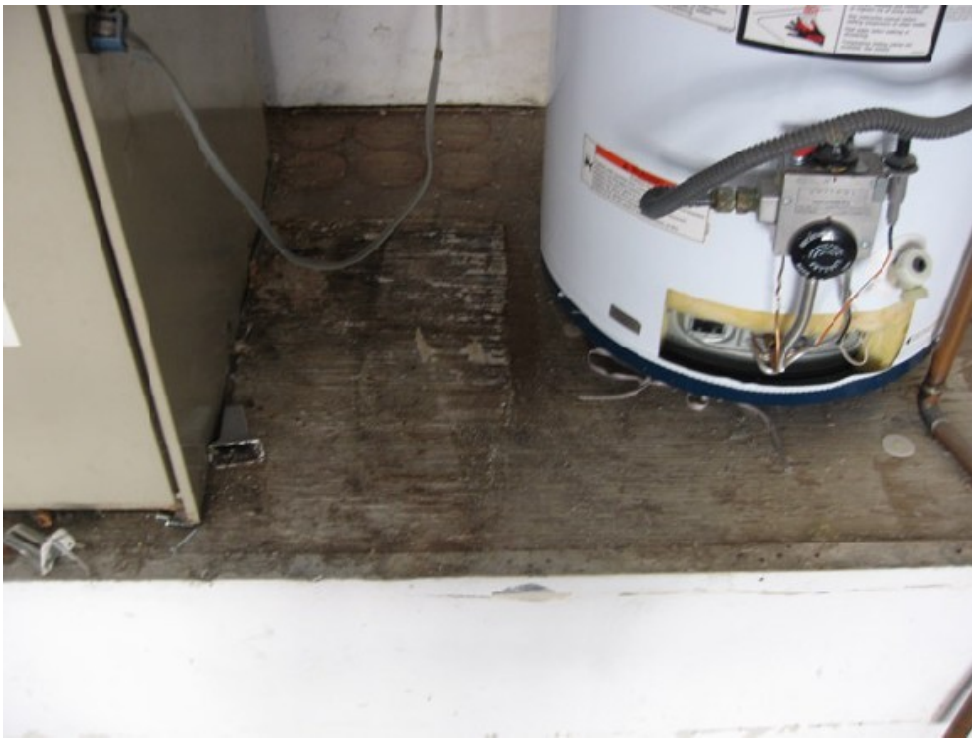
Photo 4

Evidence of water damage at platform for hot water heater and FAU

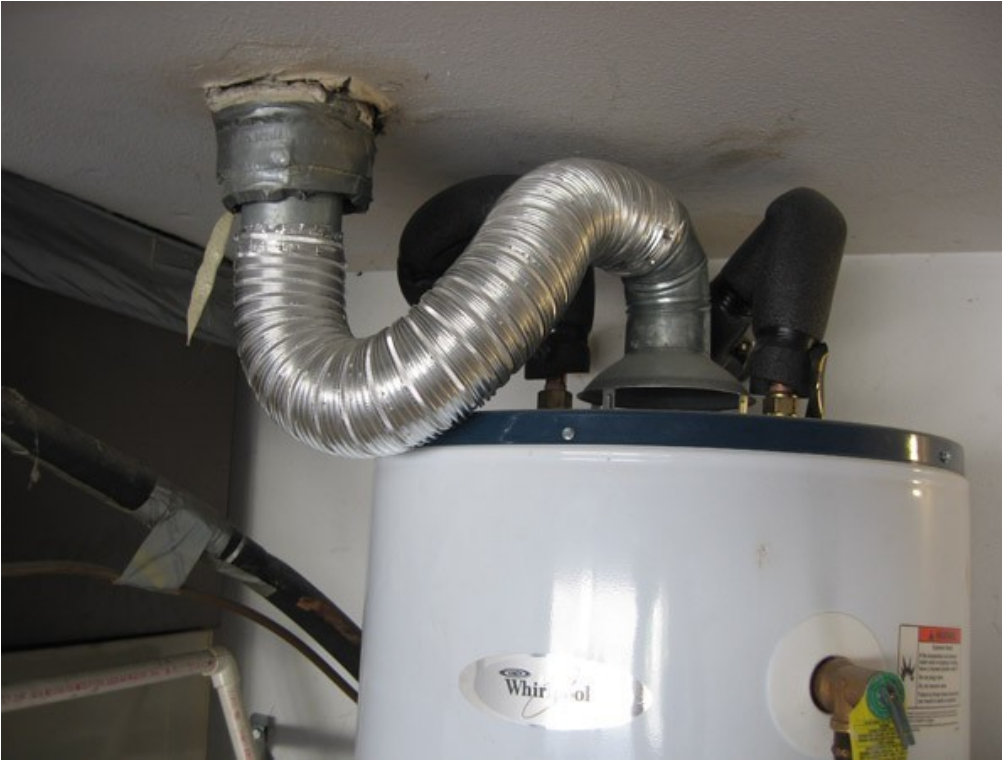
Photo 1

Based on the location of the water heater Incorrect venting material was used (aluminum flex pipe) water heater too high to ceiling and flex pipe has more than angles greater than 90 degrees and vents downwards to accommodate water heater. This is a potential safety hazard, and may result in a fire hazard. A qualified contractor should evaluate and make repairs as necessary.
